# TEST REPORT

Report No. : BJ-R250915104A-02-EN  
Test Item : High Temperature Test  
Client : LEXINGTON LIMITED  
Address : Unit 08, 17th Floor, CitiCorp Centre,  
No. 18 Whitfield Road, Hong Kong

Sample Name	PP Lid for Microwavable 316L Stainless Steel Container
Sample Model	SSBOX2-800-PPCOVER
Trademark	Lexngo
Sample No.	BJ-R250915104A-1#~6#
Sample Size	/
Weight Of Sample	/
Sample Quantity	6 PCS
Manufacturer	Laotesi Company Limited
Address	Huamei industrial Area, Caitong Town, Chaoan District, Chaozhou, Guangdong, China
Sample Source	Commissioned units send sample
Inspection Type	Commissioning test
Sample Description	Sample appearance is good

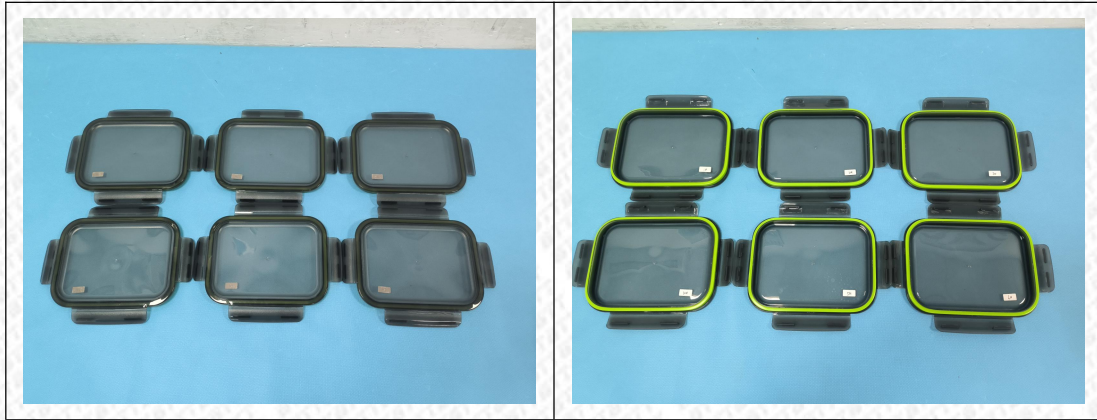
Before test

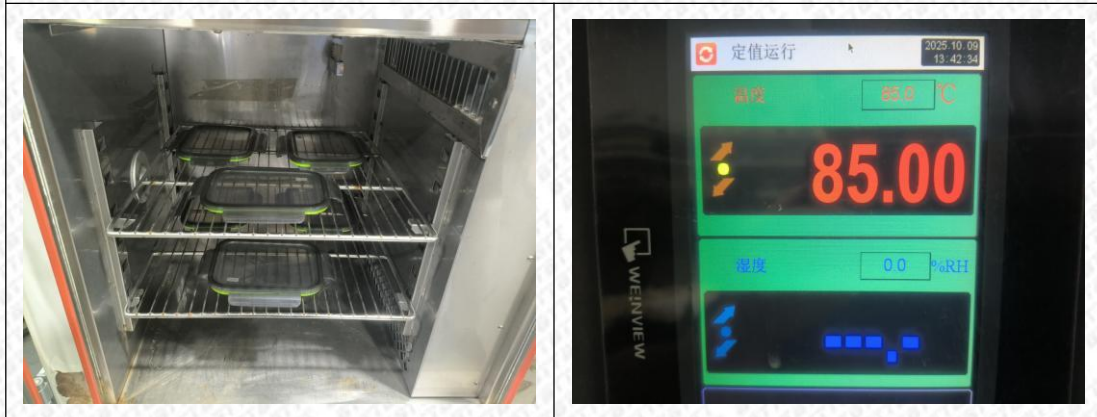
85°C

Test setup

Temperature 1:  $85^{\circ}\text{C}$     Duration: 2H  
Temperature 2:  $90^{\circ}\text{C}$     Duration: 2H

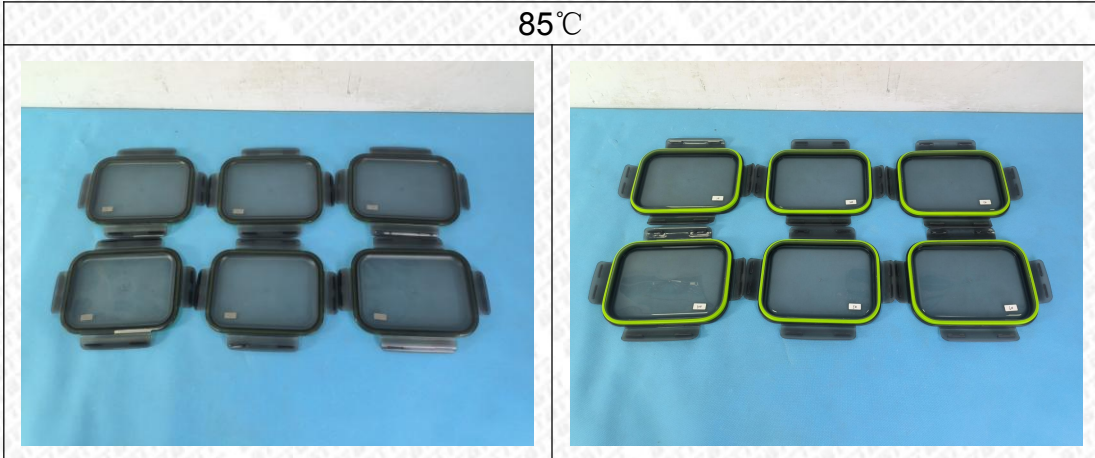
85°C

After test

Test Items	Test Results
High Temperature Test	After test, there was no obvious change in the appearance of the samples.
